### Salems Golf Club, Sweden

*Unique Rain Bird hybrid solution reduces future operating costs by 90%*

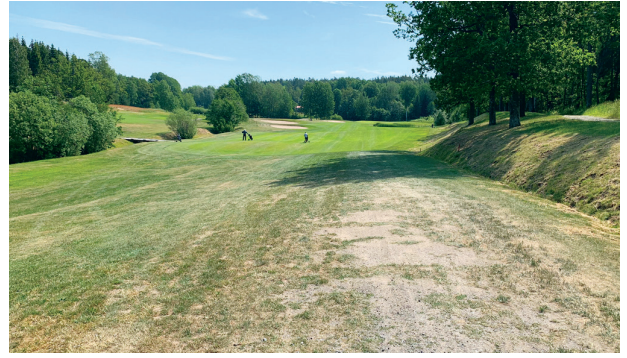
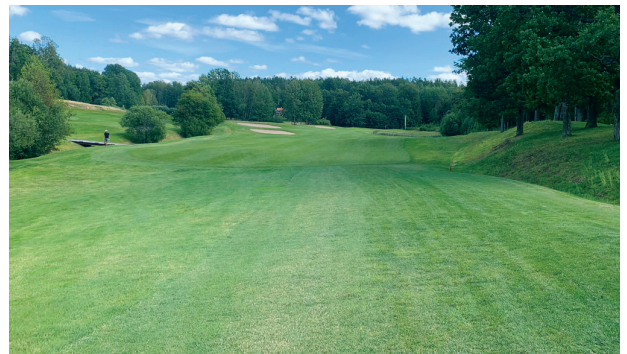
Before and after the irrigation system renovation

The irrigation renovation involved installing a Rain Bird IC System™ with Stratus II™ Central Control and just over 1000 rotors in all. The unique Rain Bird hybrid solution designed by Stuart Tate allows the 18-hole course on the IC System to run in parallel with the 9-hole course running on a decoder system, effectively running two systems as one.

Having valve-in-head (VIH) rotors rather than heads in a block formation, gives the club better control over irrigation on a rotor by rotor basis. Each VIH rotor has a built-in solenoid valve controlled independently of others on the system with its own operational parameters such as arc of rotation, precipitation rate and operational run-time, with much greater control of the area being irrigated.
